Upper Herring Lake Drone Survey 2020

Upper Herring Lake, Water Milfoil Drone Survey
Benzie Conservation District
10/15/20
John@benziecd.org

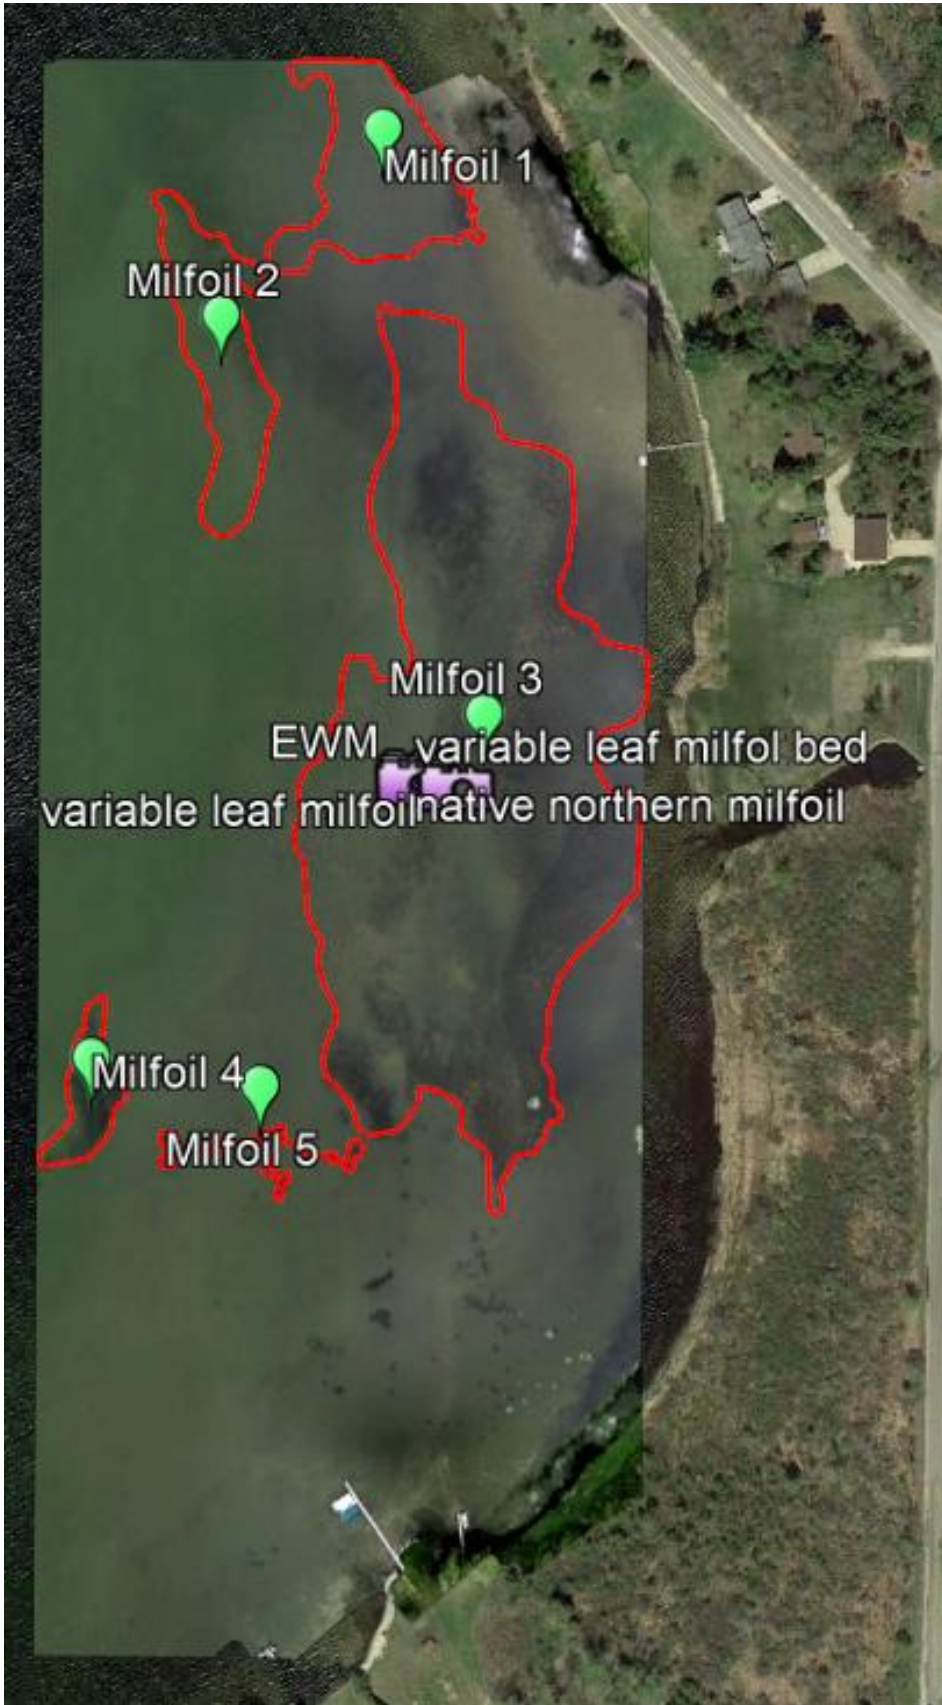
Figure 1. Ortho-mosaic photo 1 Upper Herring Lake littoral zone - inlet (east shore).

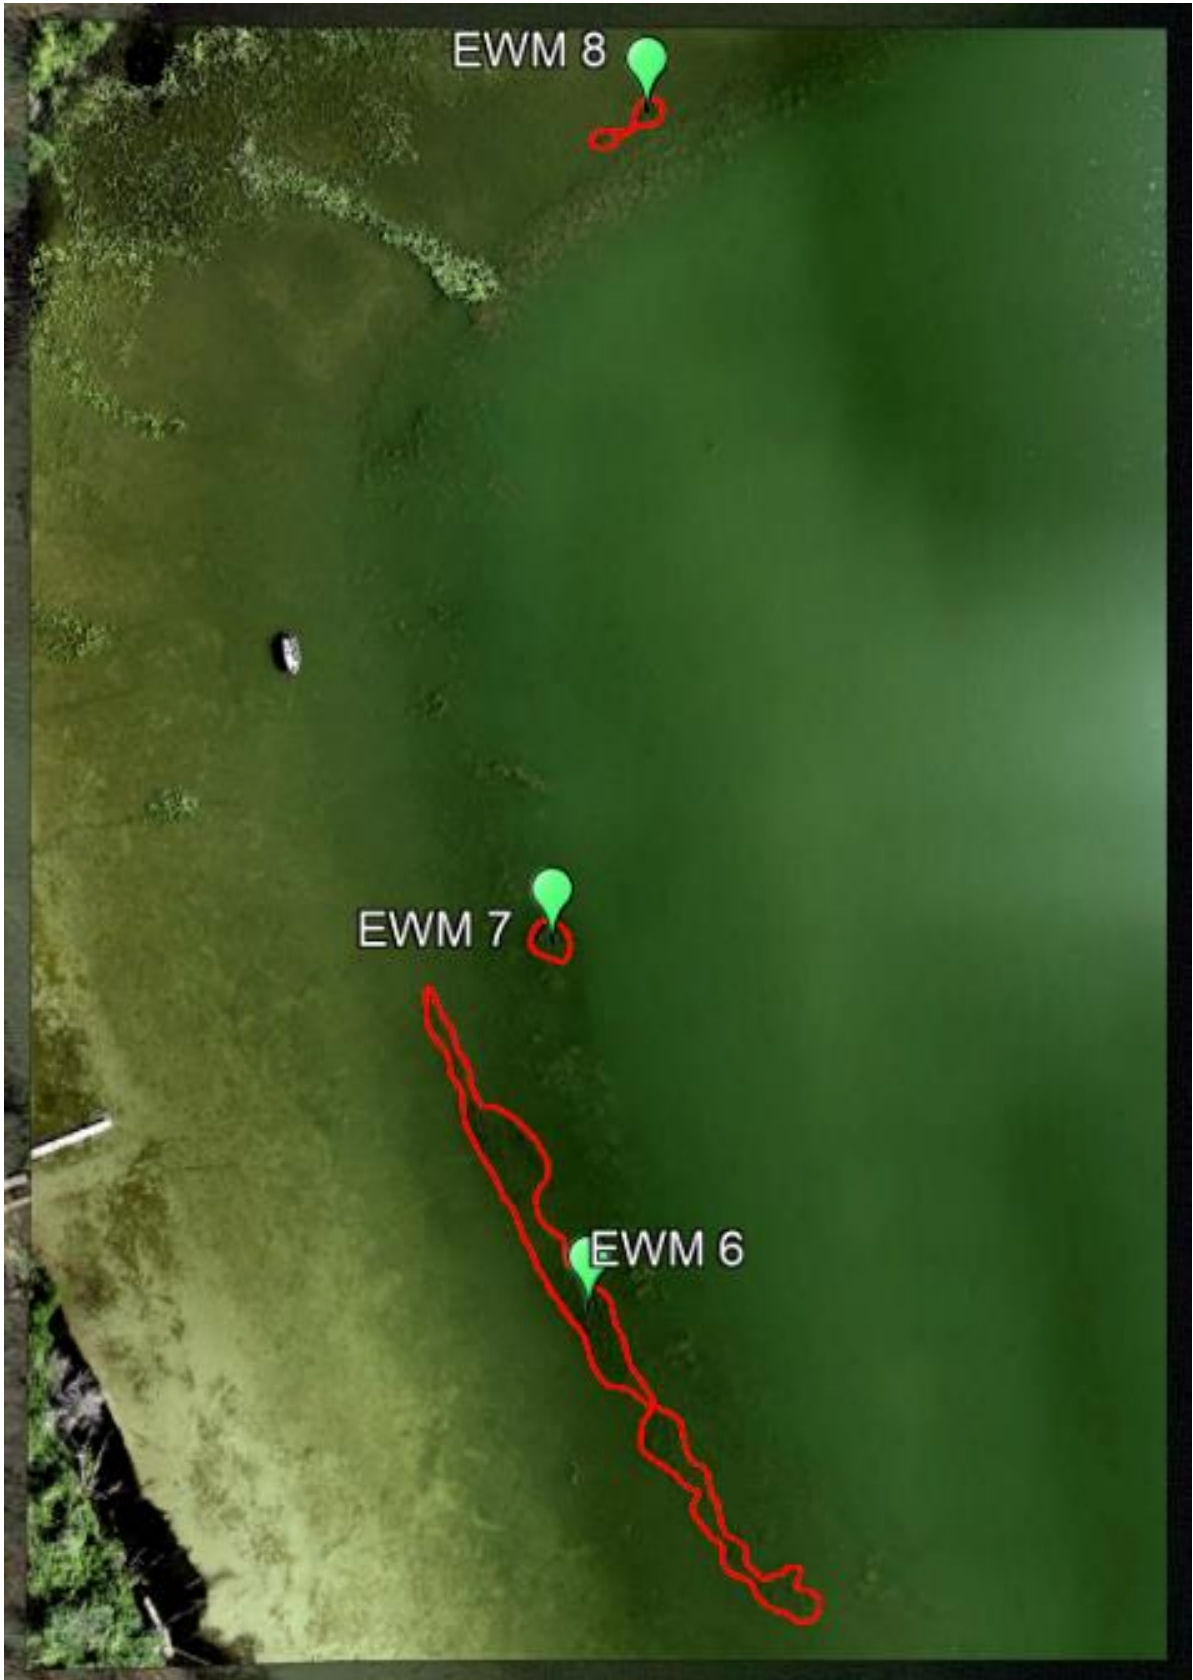
The largest and most dense area of EWM was near the Outlet/DNR boat launch (101,226 ft²:figure 4). EWM was found in this area in 2018 during a snorkeling survey found the EWM to be well mixed with native pondweeds and was not outcompeting other vegetation. The large patches of milfoil near the inlet were mostly variable leaf milfoil, however EWM and northern milfoil was also found within those patches (figure 1). EWM patches along the south and west shore lines were smaller and mixed with native pondweeds (figures 2,3).

Figure 2. Ortho-mosaic photo 2 Upper Herring Lake littoral zone - southwest corner.

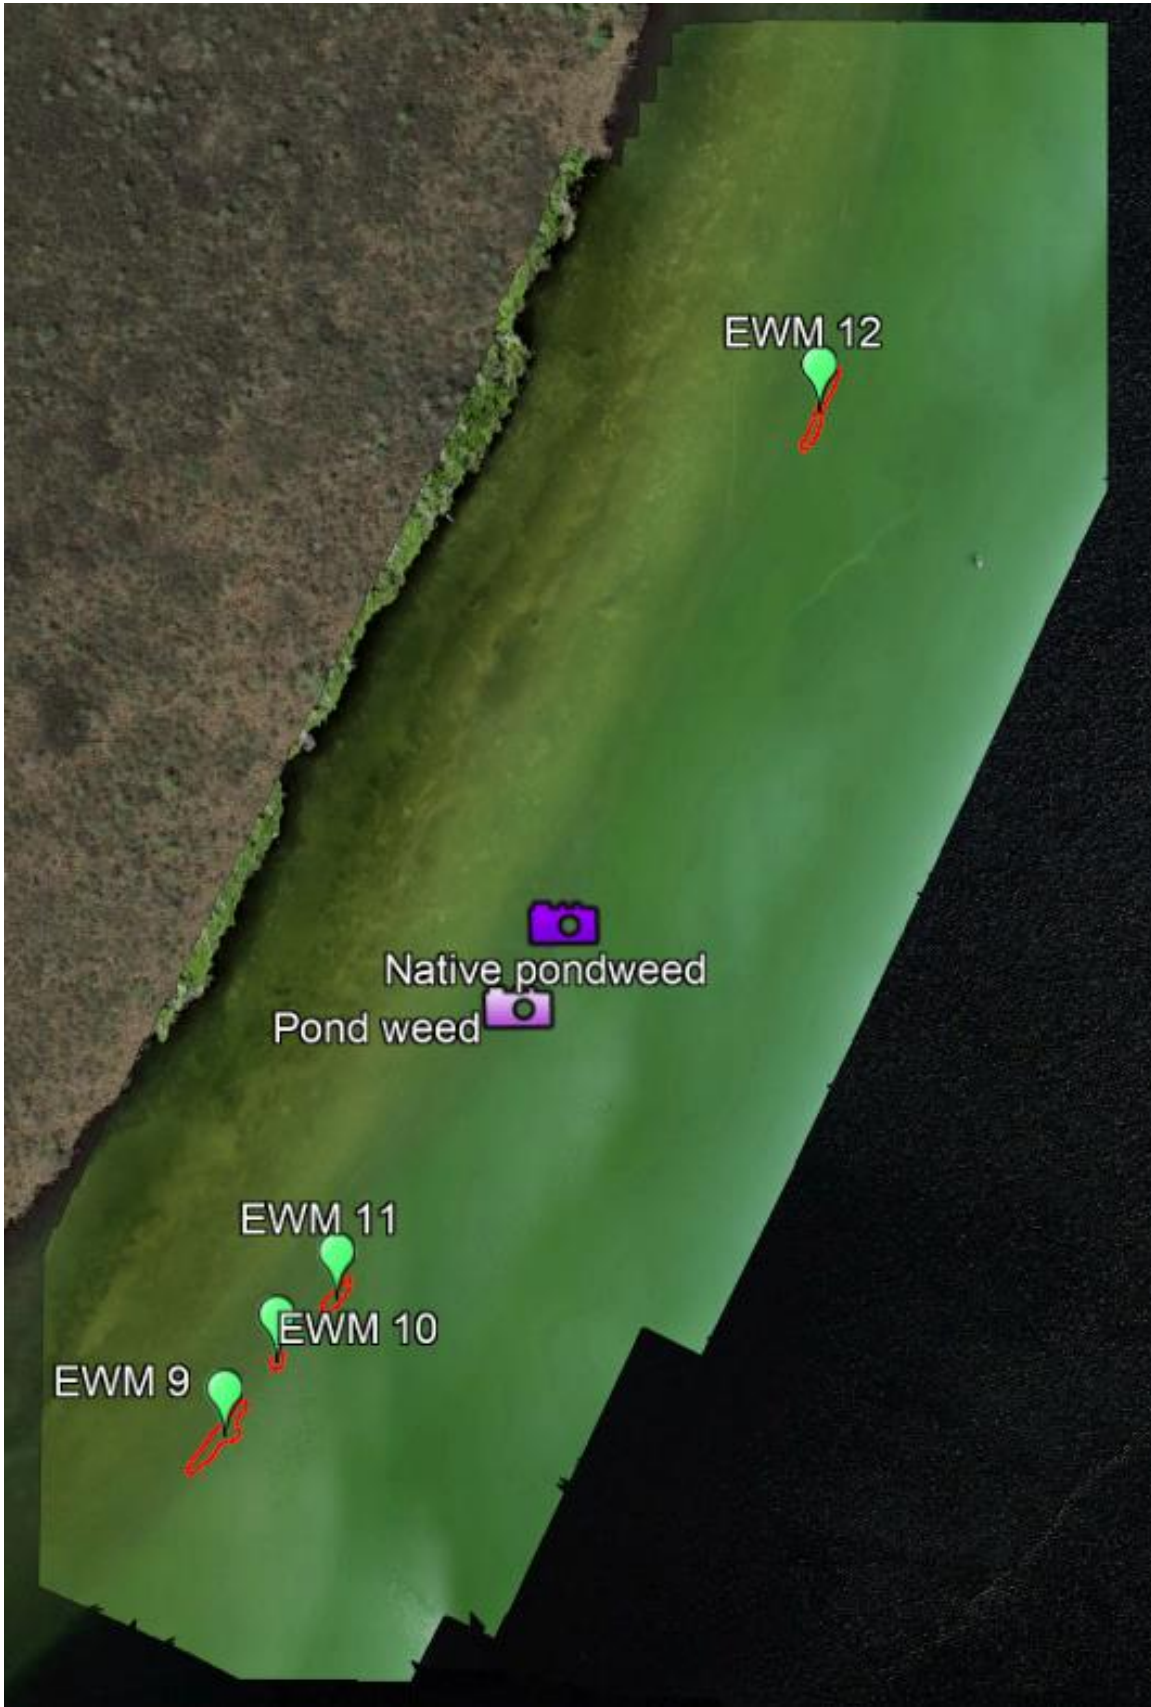
Figure 3. Ortho-mosaic photo 3 Upper Herring Lake littoral zone - west shore

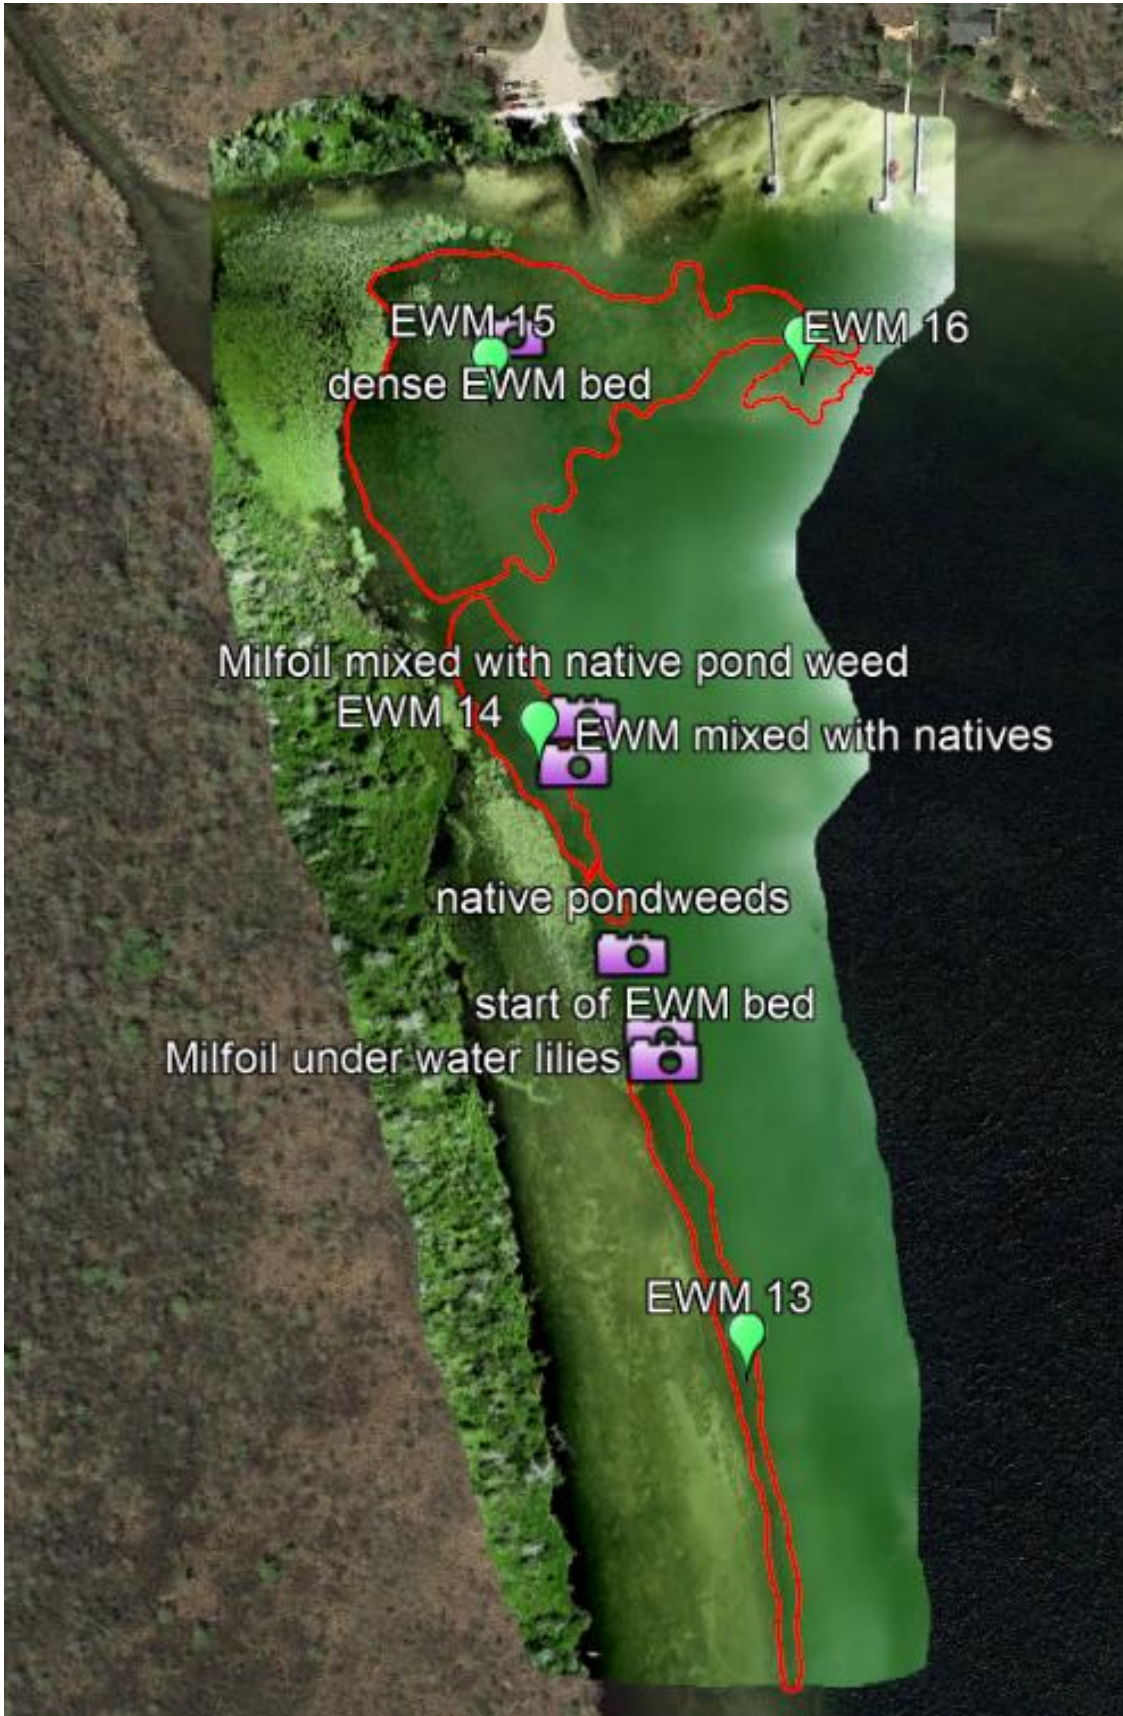
Figure 4. Ortho-mosaic photo 4 Upper Herring Lake littoral zone - Outlet/DNR boat launch.
